**MODIFIED PHASE I ENVIRONMENTAL SITE ASSESSMENT**

Oak Flat Radio Tower Project  
9193 Black Star Canyon Road  
Silverado, California  
Orange County

**Re: Modified Phase I Environmental Site Assessment  
Site PA100028 (Oak Flat)  
9193 Black Star Canyon Road  
Silverado, California  
Orange County**

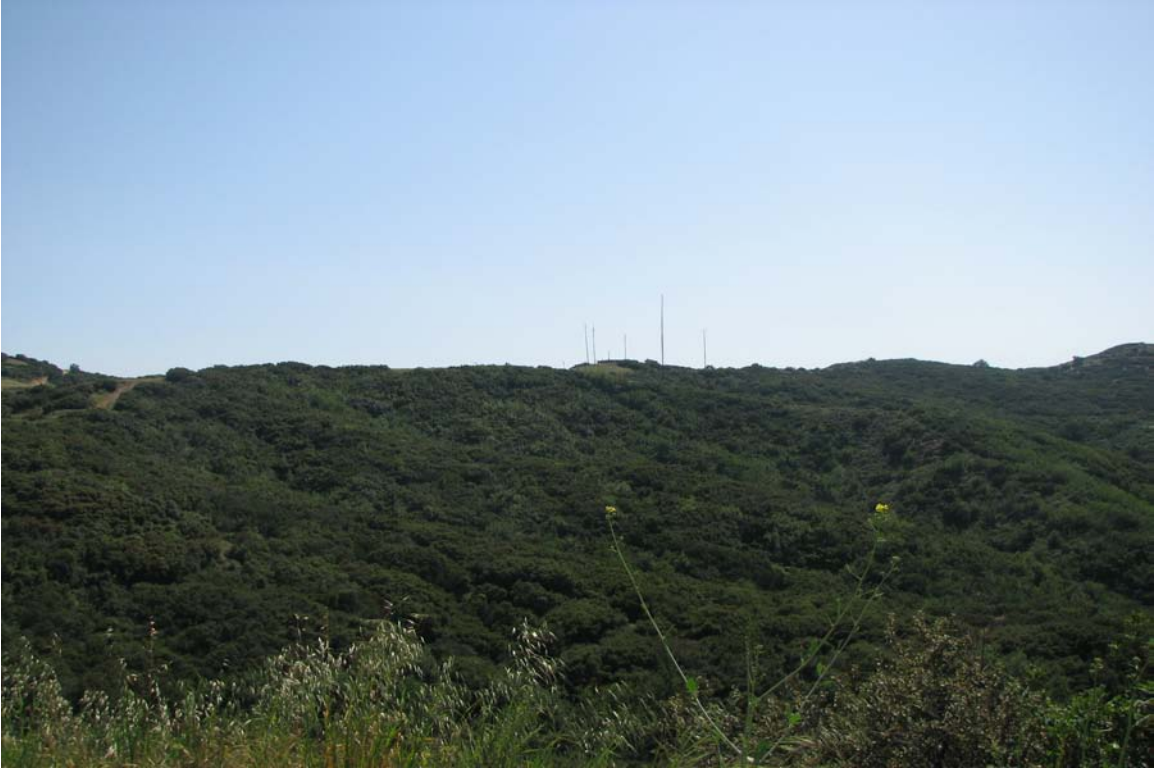
View of the northern portion of the Property and adjacent properties to the north, west, and east, photograph taken looking southwest.

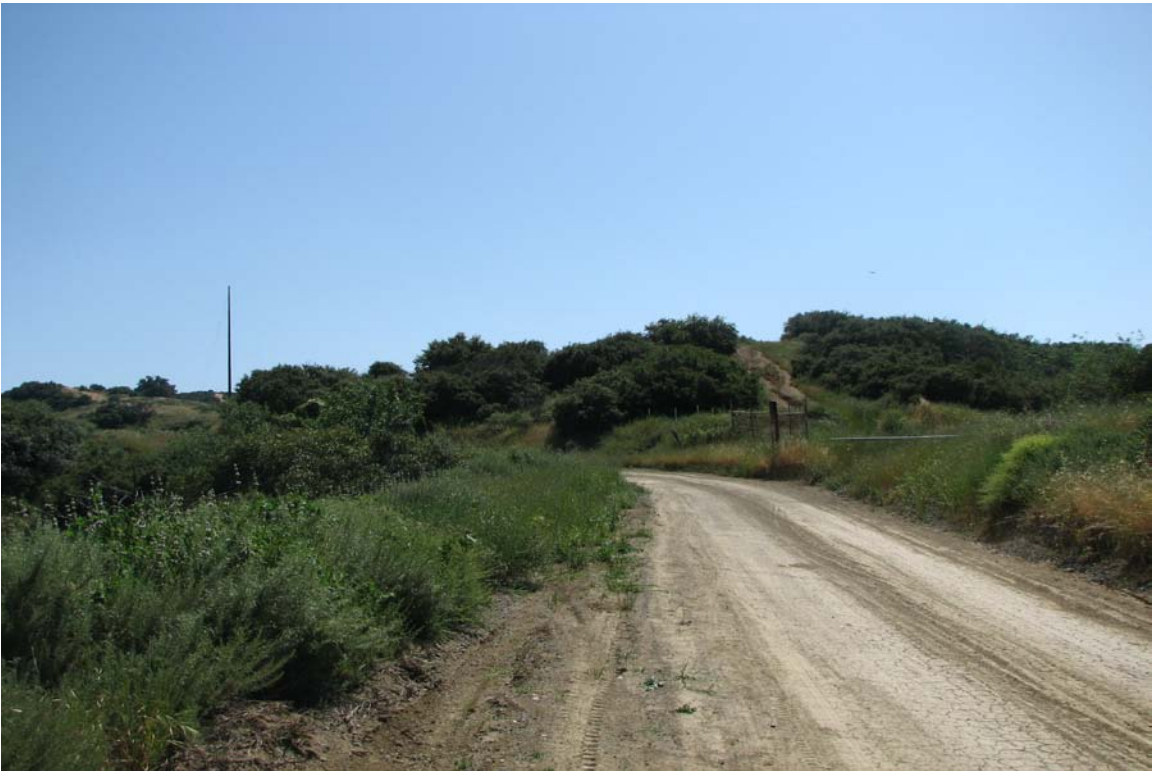
View of the northeastern portion of the Property, site access road, and adjacent properties to the east, photograph taken looking southwest.

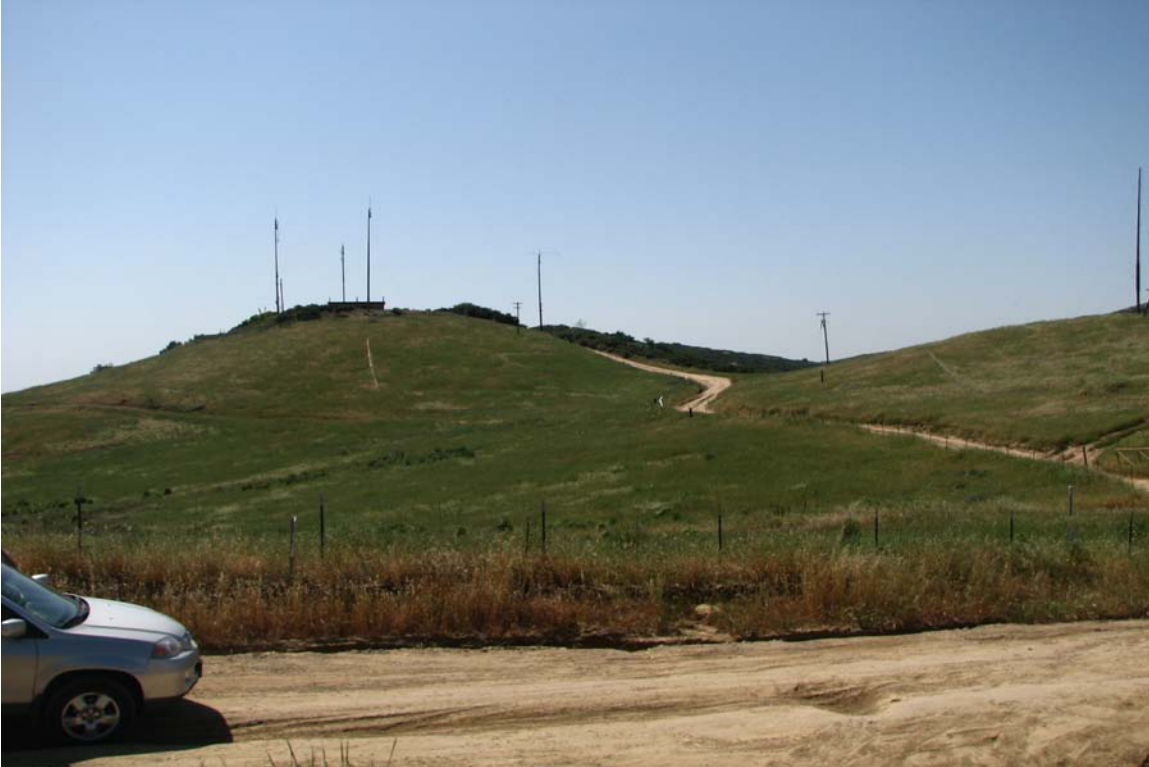
View from the east-southeastern portion of the Property toward the central portion of the Property, photograph taken looking west-northwest.

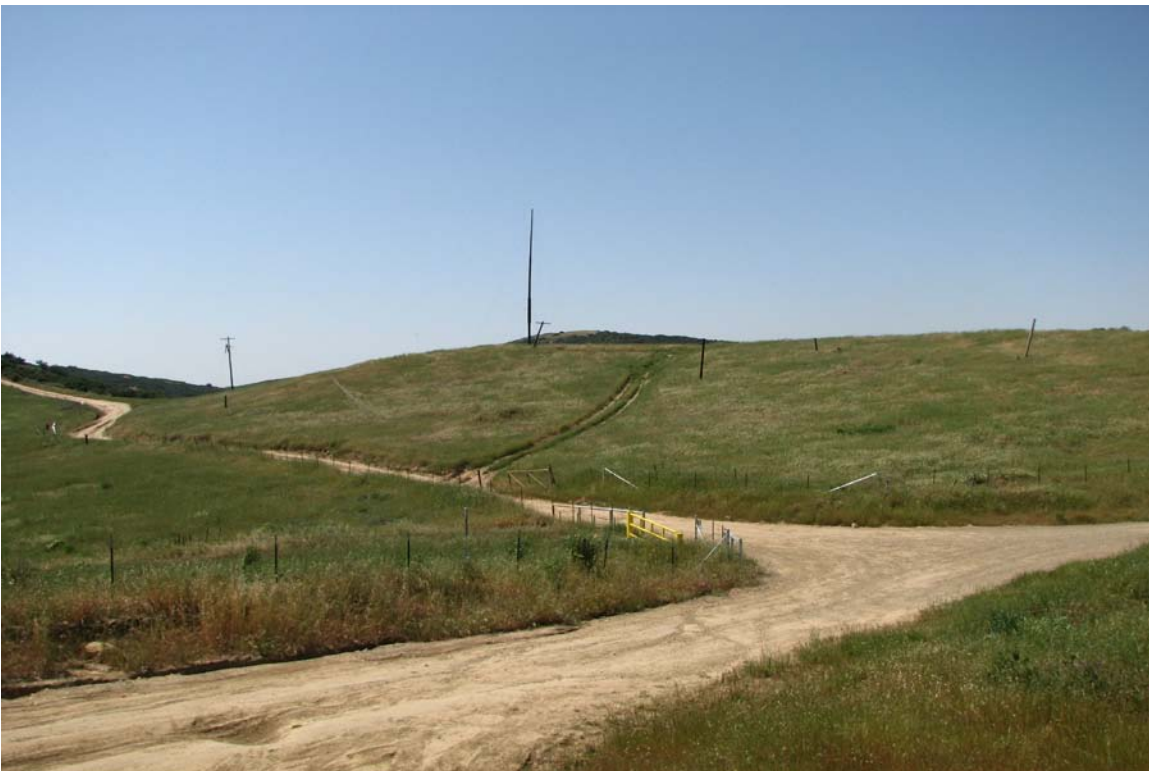
View from the east-southeastern portion of the Property toward the north-central portion of the Property, photograph taken looking northwest.

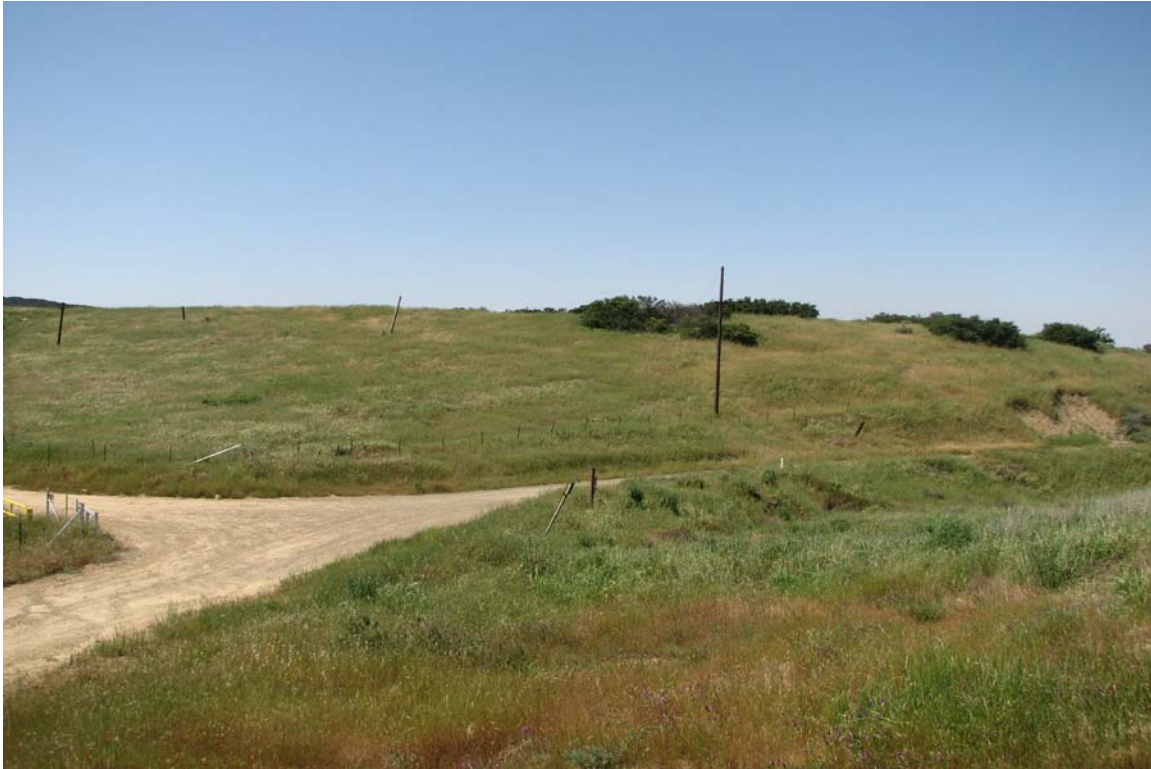
View from the east-southeastern portion of the Property toward the northeastern portion of the Property, photograph taken looking north-northwest.

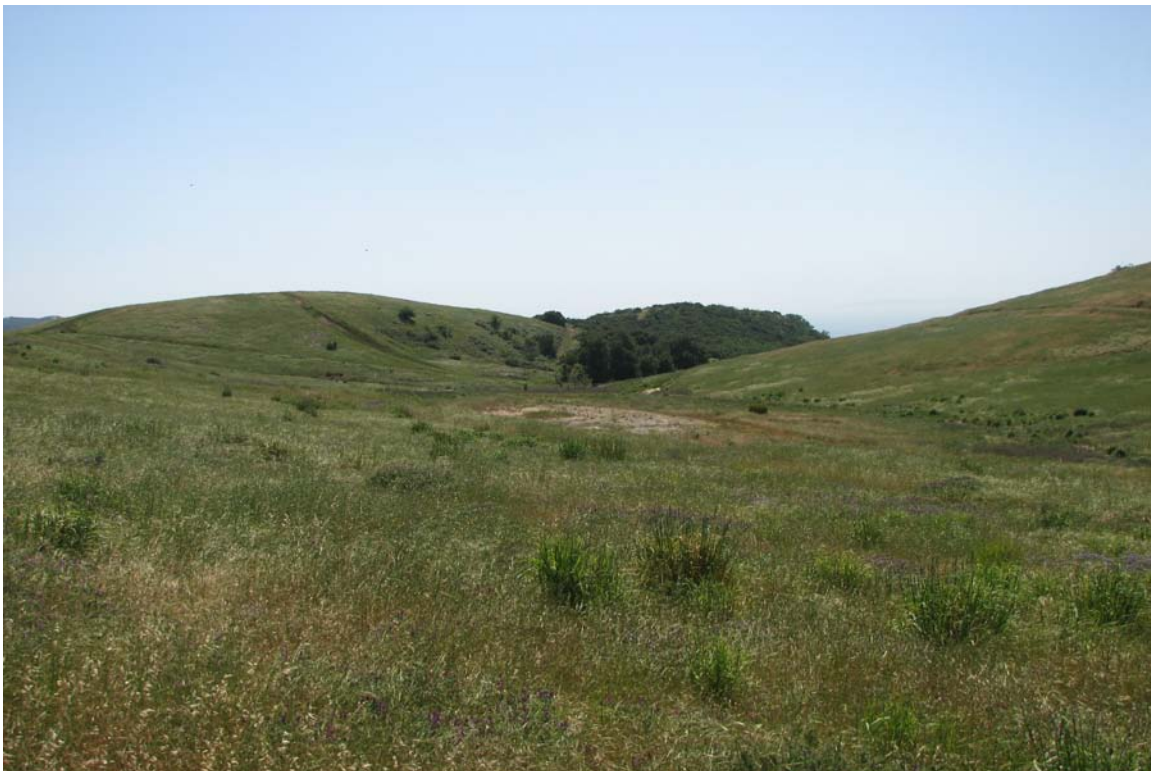
View from the east-northeastern portion of the Property toward the central portion of the Property, photograph taken looking southwest.

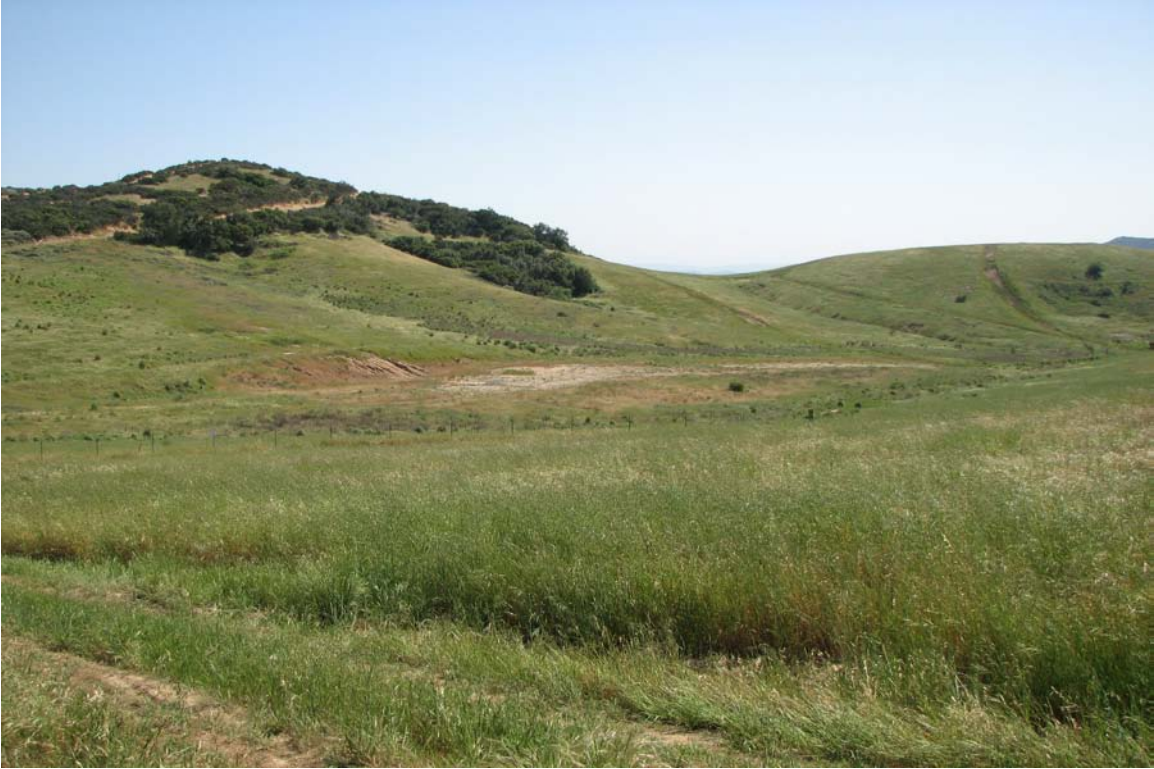
View from the north-central portion of the Property toward the central portion of the Property, photograph taken looking south.

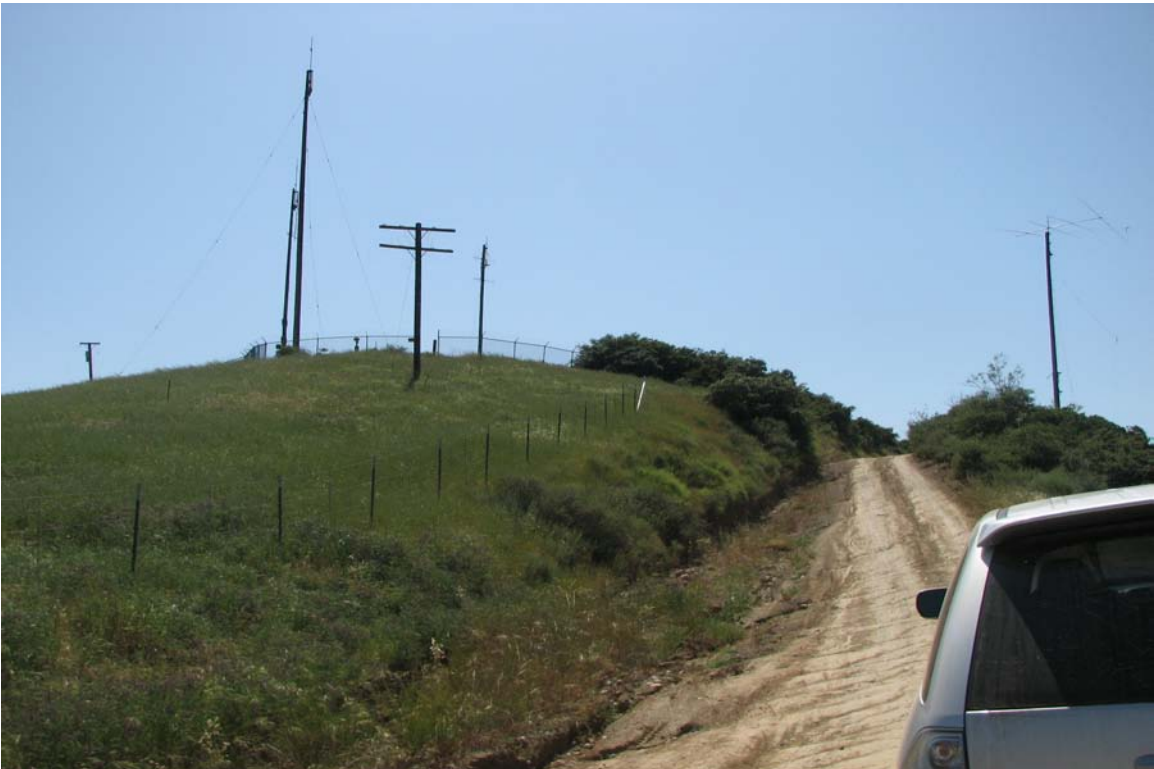
View from the north-central portion of the Property toward the northwestern portion of the Property, photograph taken looking west.

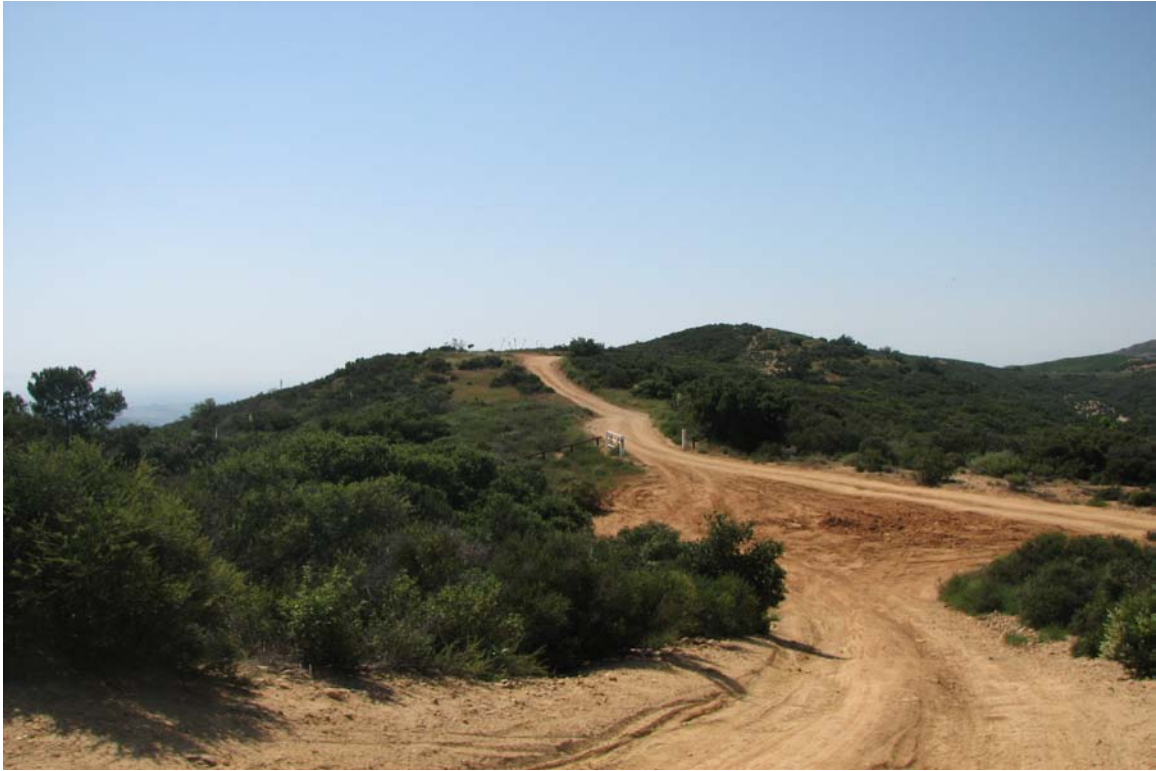
View from the northwestern portion of the Property toward the northwestern corner of the Property and of the site access road, photograph taken looking northwest.

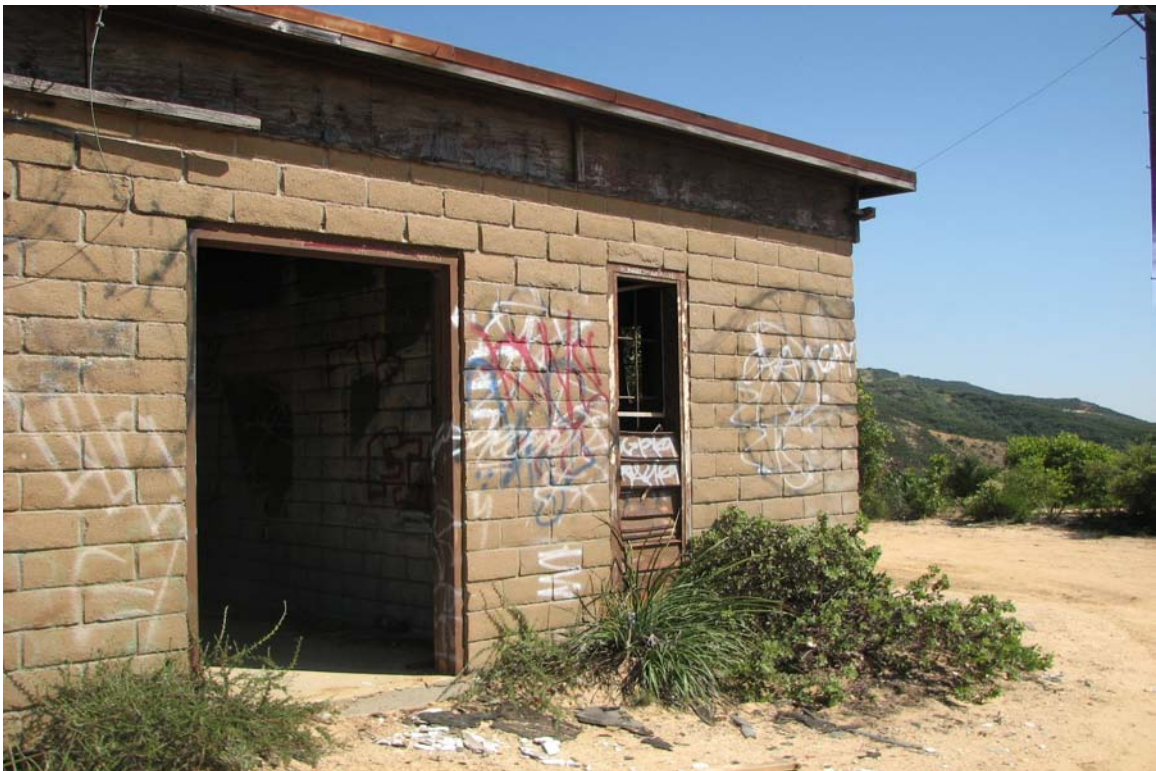
View of the on-site structure located on the northwestern portion of the Property and former generator/batteries storage area, photograph taken looking southeast.

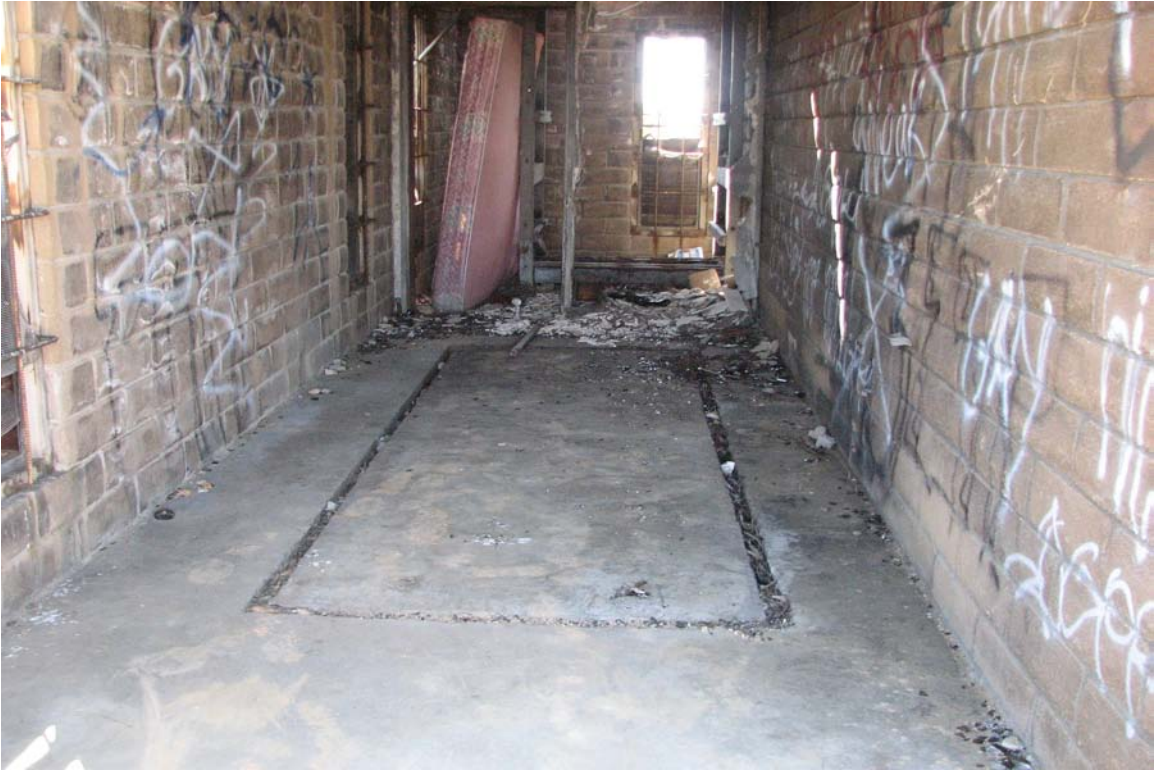
No asphalt patches were observed on the Property during the site reconnaissance. Surface staining was observed within the southern portion of the on-site building. According to the provided information, this section of the building was used as a battery and generator storage area. Due to the past identified uses and present staining of this area, and location (upgradient) to the proposed northwestern antenna structure, a recognized environmental condition exists for the Property and proposed development.

View of the generator/batteries storage area and surface staining.

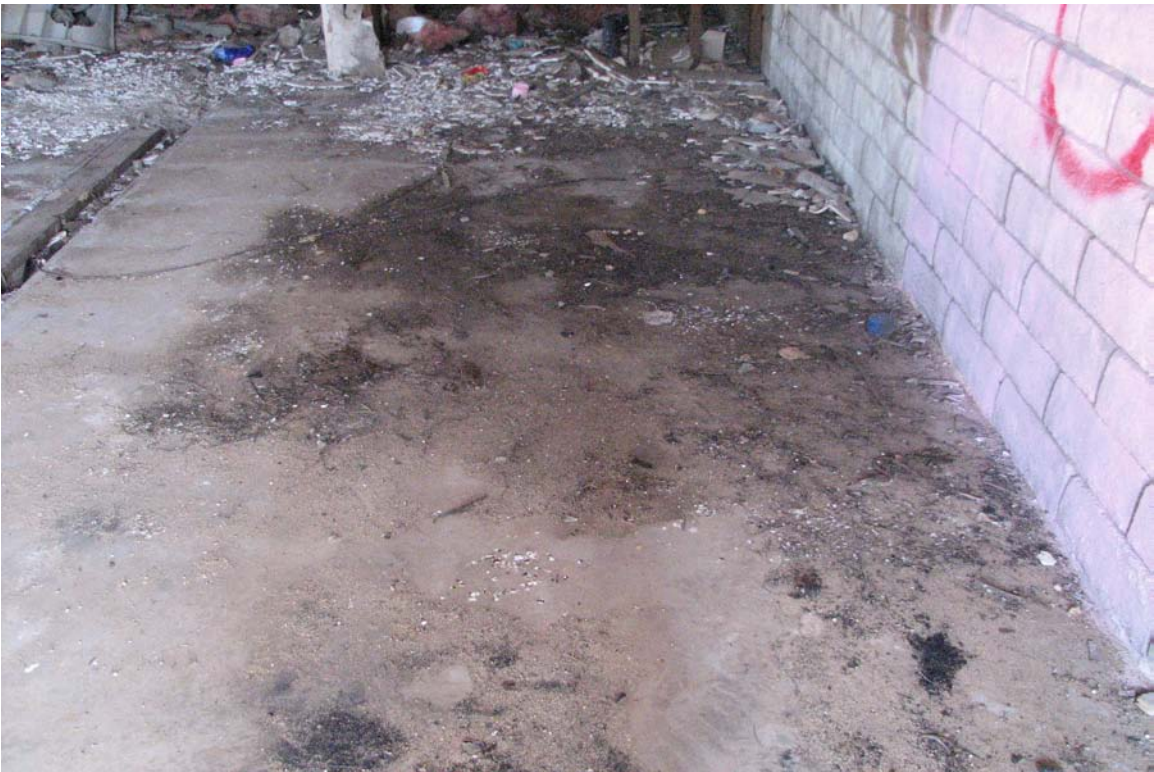
View of the surface staining within the on-site building.

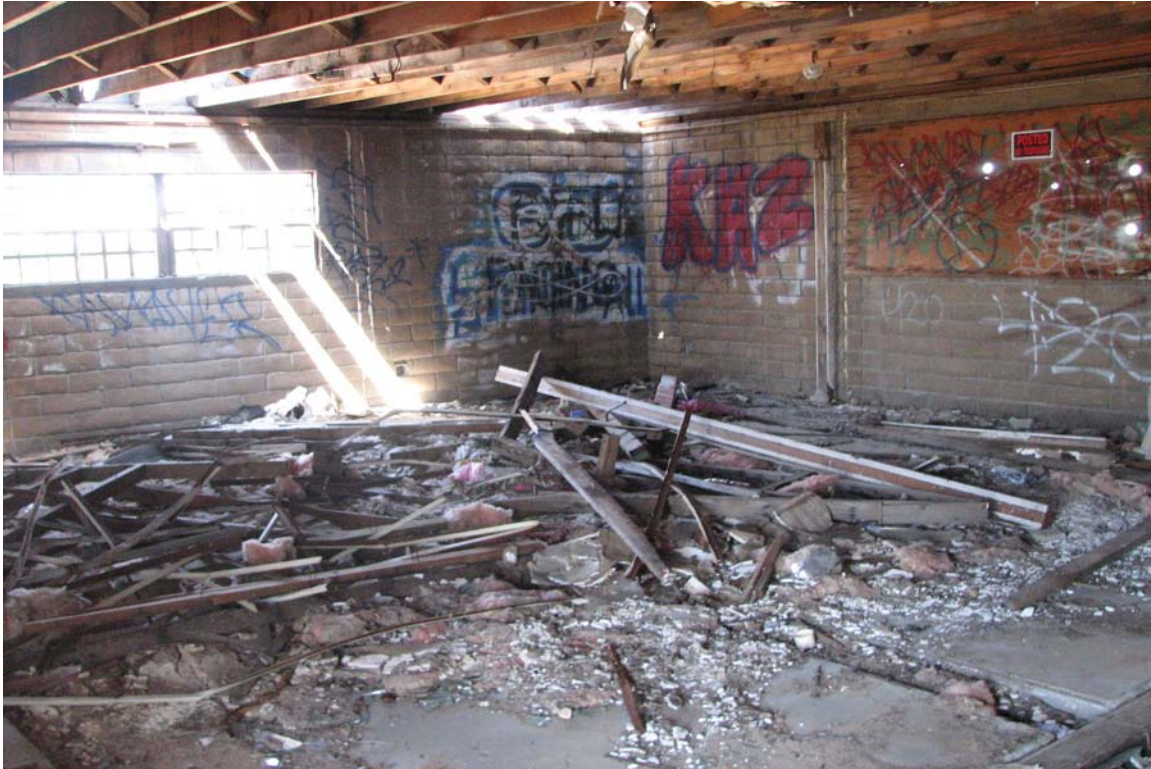
View of the northern portion of the interior of the on-site building.

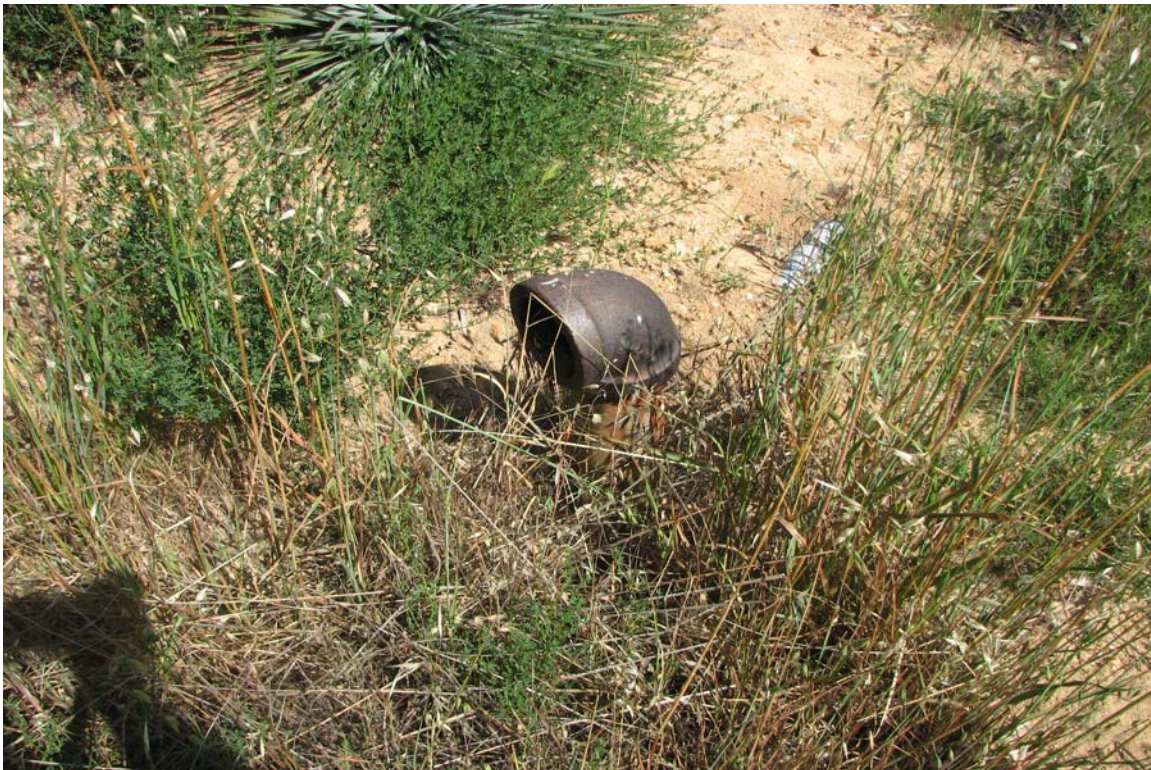
A vent pipe, possibly indicating the presence of a petroleum hydrocarbon underground storage tank (UST) and an aboveground storage tank (AST) were observed on the northwestern portion of the Property during the site visit. The vent pipe was located at the top portion of the southern slope, approximately 35 to 40 feet south-southeast of the on-site building. The AST was located on the southern slope approximately 68 feet south of the building, and 12 feet north of the chain-link fencing. No staining was observed in these areas, however vegetation had overgrown most of these areas around the tank and vent pipe. Reviews of the FirstSearch government database report indicated two USTs associated with the Property and Orange County Environmental Health Department records indicated that one registered USTs associated with the Property address. These USTs are identified and discussed further in sections 6.0 and 7.0 below.

View of the vent pipe located on the northwestern portion of the Property, approximately 35 to 40 feet south-southeast of the on-site building.

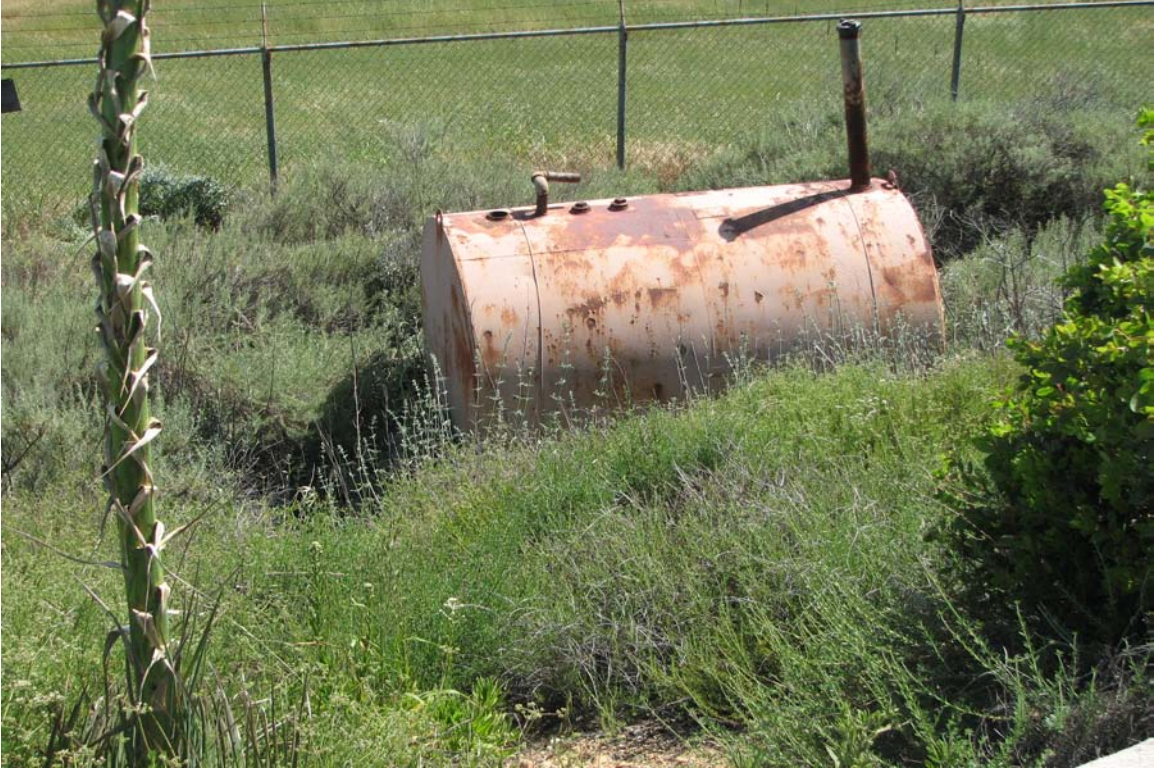
View of the former UST located on the southern slope of the northwestern portion of the Property, approximately 68 feet south of the on-site building, and 12 feet north of the fence.

PNAs. It also recommended the removal of buried transformers from the subsurface and offsite disposal following proper disposal requirements and the removal of the UST located onsite and disposal in accordance with applicable regulations. According to the previously conducted Phase I report a skid-mounted 500-gallon AST was onsite for approximately two years prior to the sale of the Property in 1999. MBA found no records associated with this AST with any government agency. A Phase II ESA, was conducted by GeoSoils, Inc. (GSI) March 3, 1998. GSI identified a 2,000-gallon UST located onsite above ground that is assumed to be the former UST Dr. Roaney identified. The GSI investigation included excavation of the former UST backfill, soil sampling and analysis of the backfill materials. Transformers were exposed during the fieldwork at a depth of approximately 6 feet below ground surface. Associated piping from the UST to the building was also excavated. According to GSI no soil staining was apparent in the backfill material or along the piping. A soil sample collected from beneath the buried transformers indicated that concentrations of total petroleum hydrocarbon (TPH), polynuclear aromatics (PNA), organic lead and PCBs were less than the laboratory detection limits. GSI reported that staining was apparent on the floor and lower portions of the brick walls of the generator room suspected to be from generator exhaust. Soil samples collected from below a vent in the southwest corner of the building were analyzed for PNAs, PCBs, TPH, volatile organic compounds, heavy metals and corrosivity. The concentration of most were less than the laboratory detection limits. Several of the metals were present above the laboratory detection limits, but less than the regulatory action levels. GSI concluded that "the overall potential for significant hazardous materials/waste and/or petroleum contamination onsite is low." GSI recommended that the "dry" transformers be removed and disposed of offsite and commented that the concrete slab of the onsite building might have to be disposed of as hazardous waste if removed in the future. MBA did not observe at the time of site reconnaissance that any of the above recommendations had been completed nor was any information available to indicate the removal or disposal of these transformers and concrete slab.

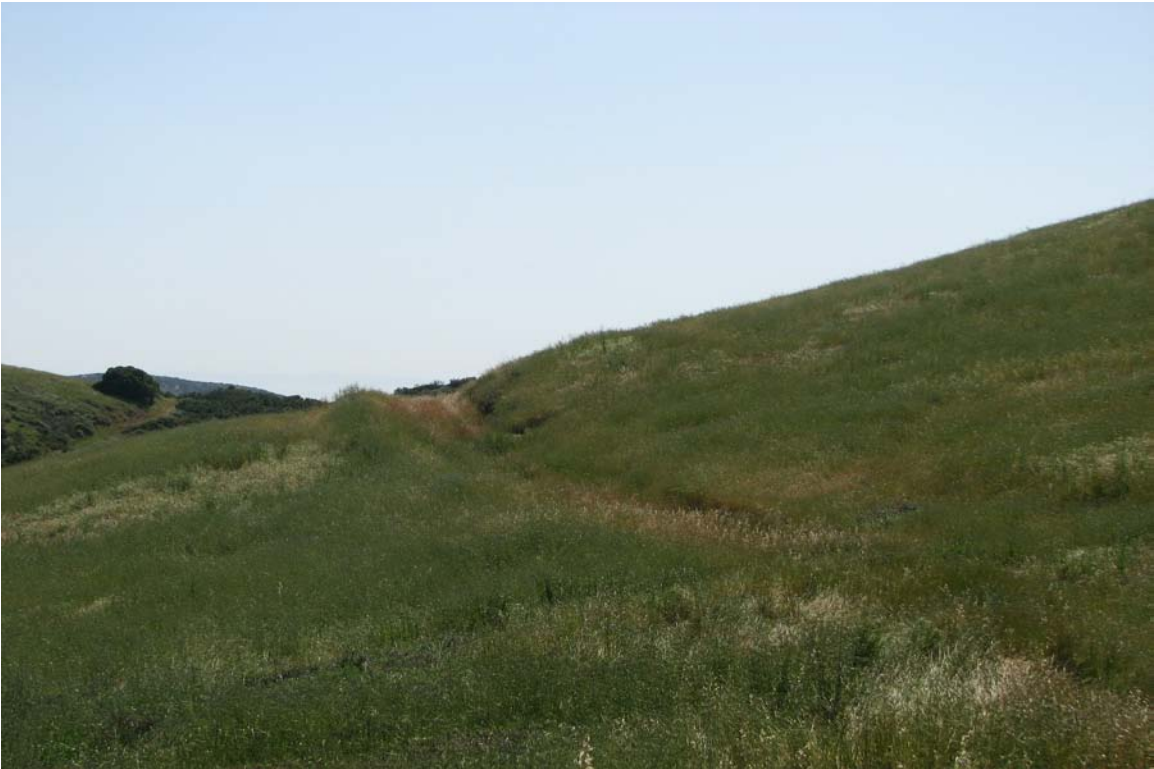
View of the northwestern portion of the Property and proposed northwestern antenna location, photograph taken looking west-southwest.

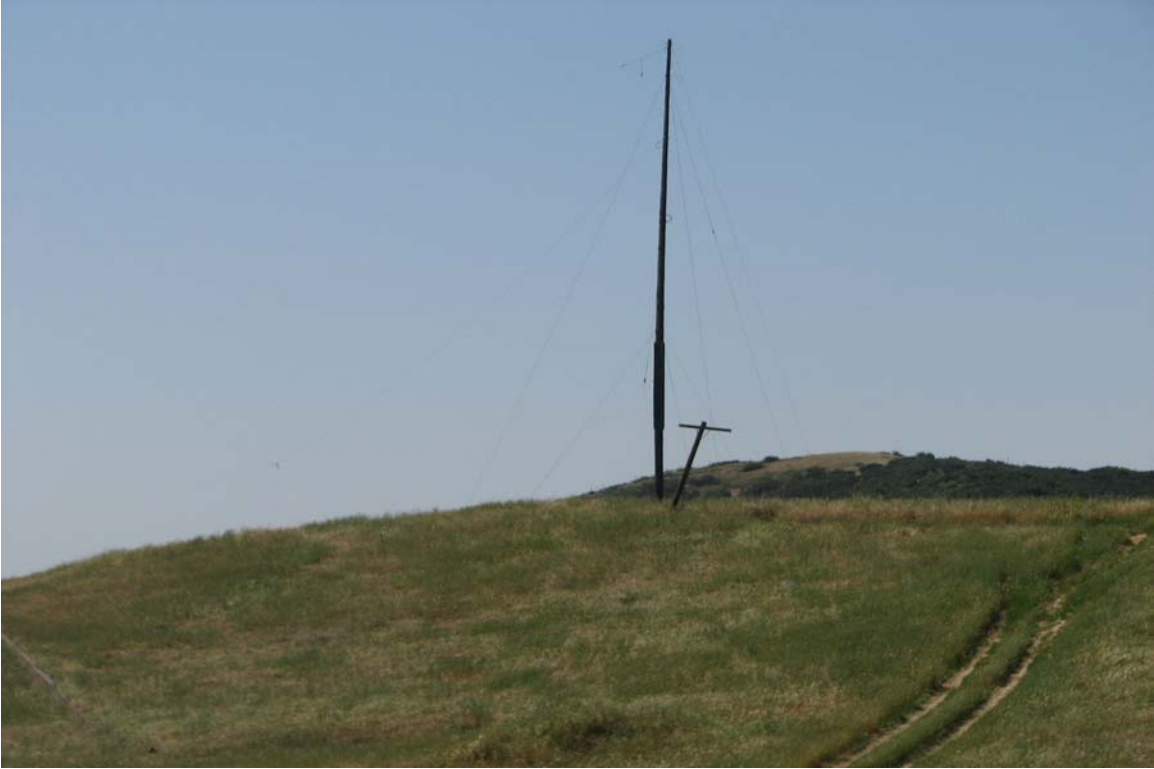
View of the northeastern portion of the Property and proposed northeastern antenna location, photograph taken looking north-northwest.

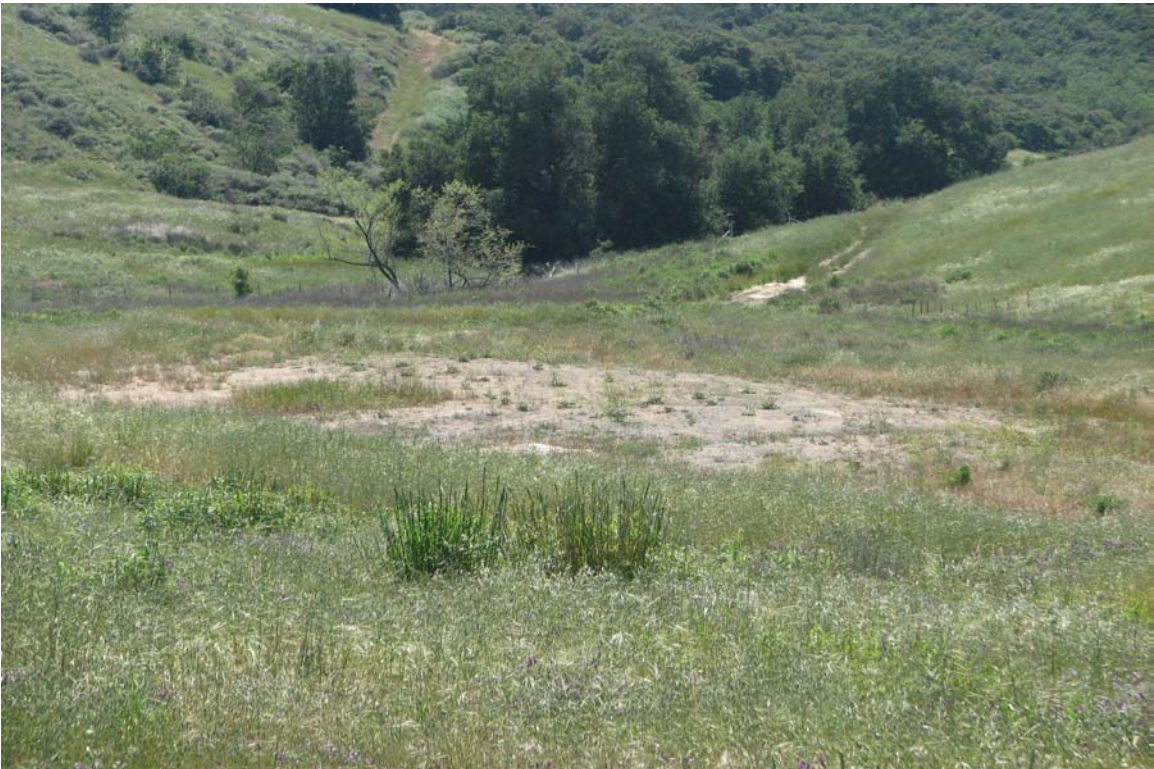
View of the central portion of the Property, two proposed antenna locations, and proposed AM radio relay station/ building, photograph taken looking southwest.
